Glade Creek Hydrogeomorphic Assessment

Apex File HA-15-KL-02

Prepared by: Kim Green, PGeo., PhD.
Apex Geoscience Consultants Ltd
Nelson, BC

January 20, 2016

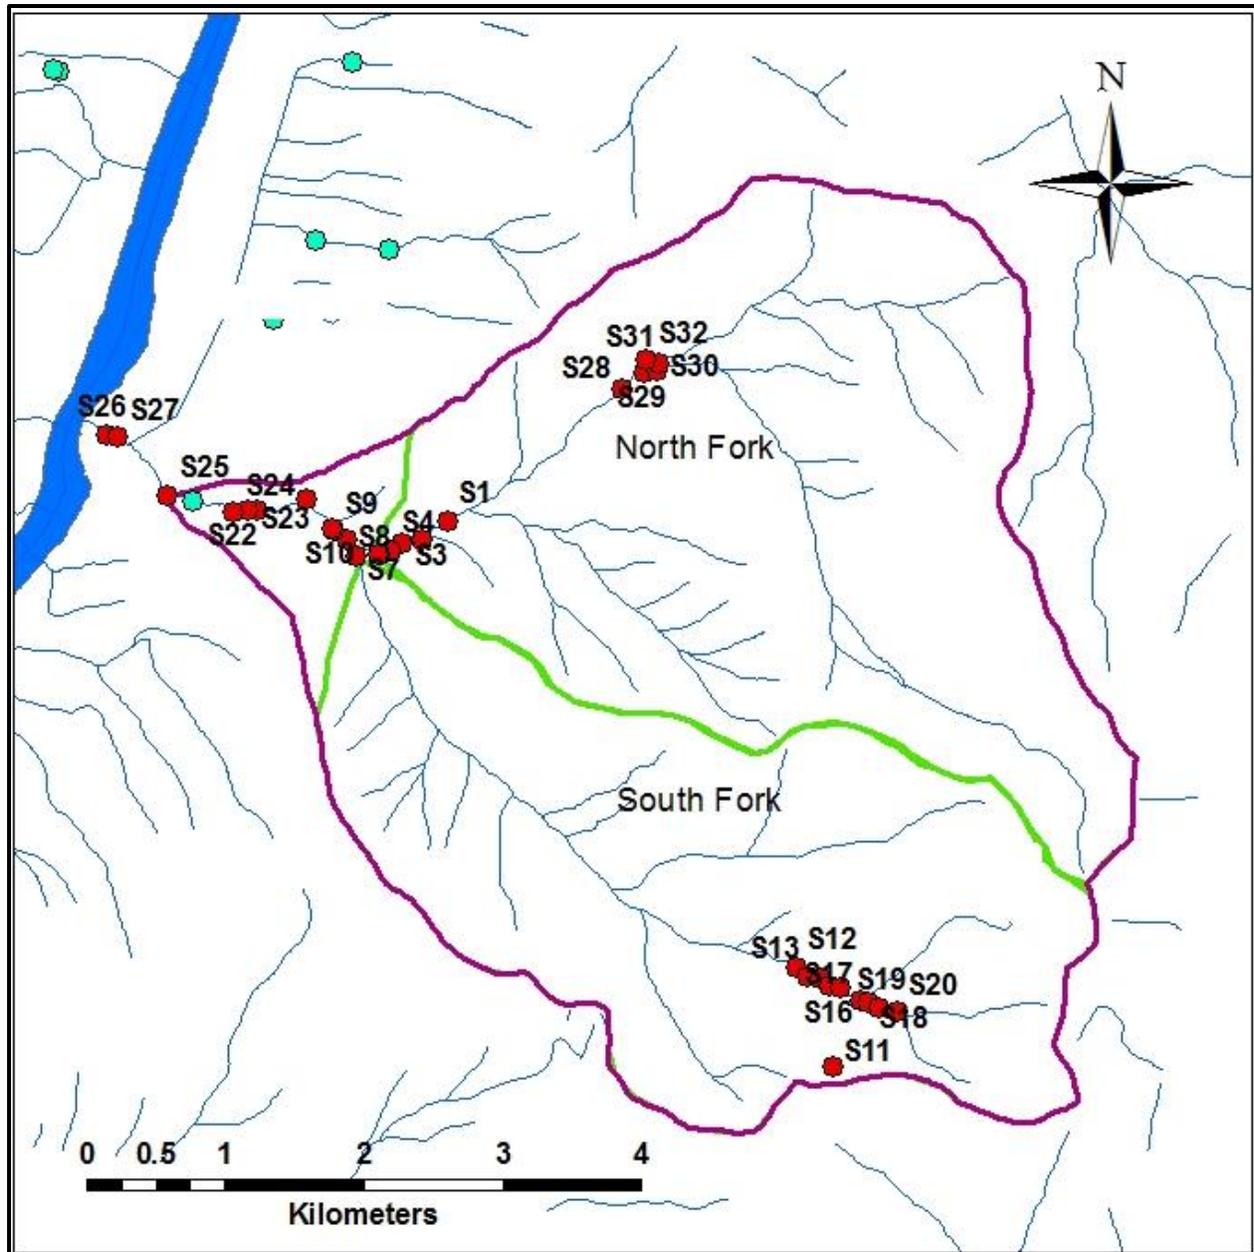
Figure 1. Glade Creek survey site locations. Blue dot marks Glade Irrigation District intake.

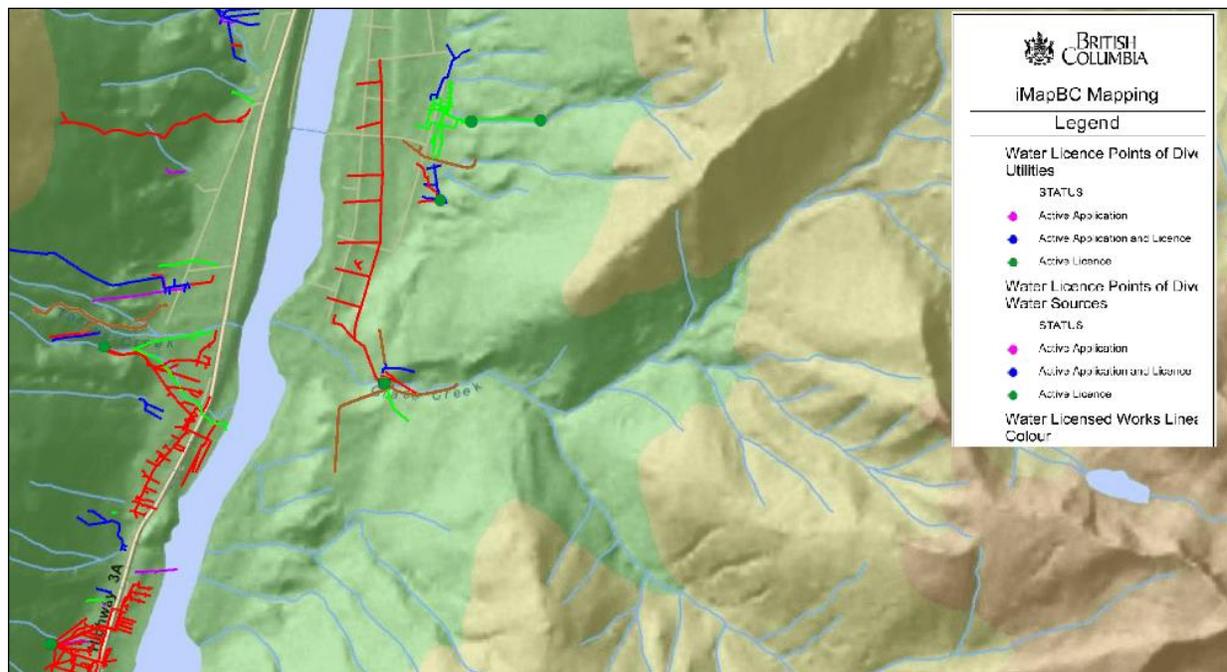
Figure 2. Water intake locations. Location of intakes (green dots) and water distributions systems (red) for Glade Creek.

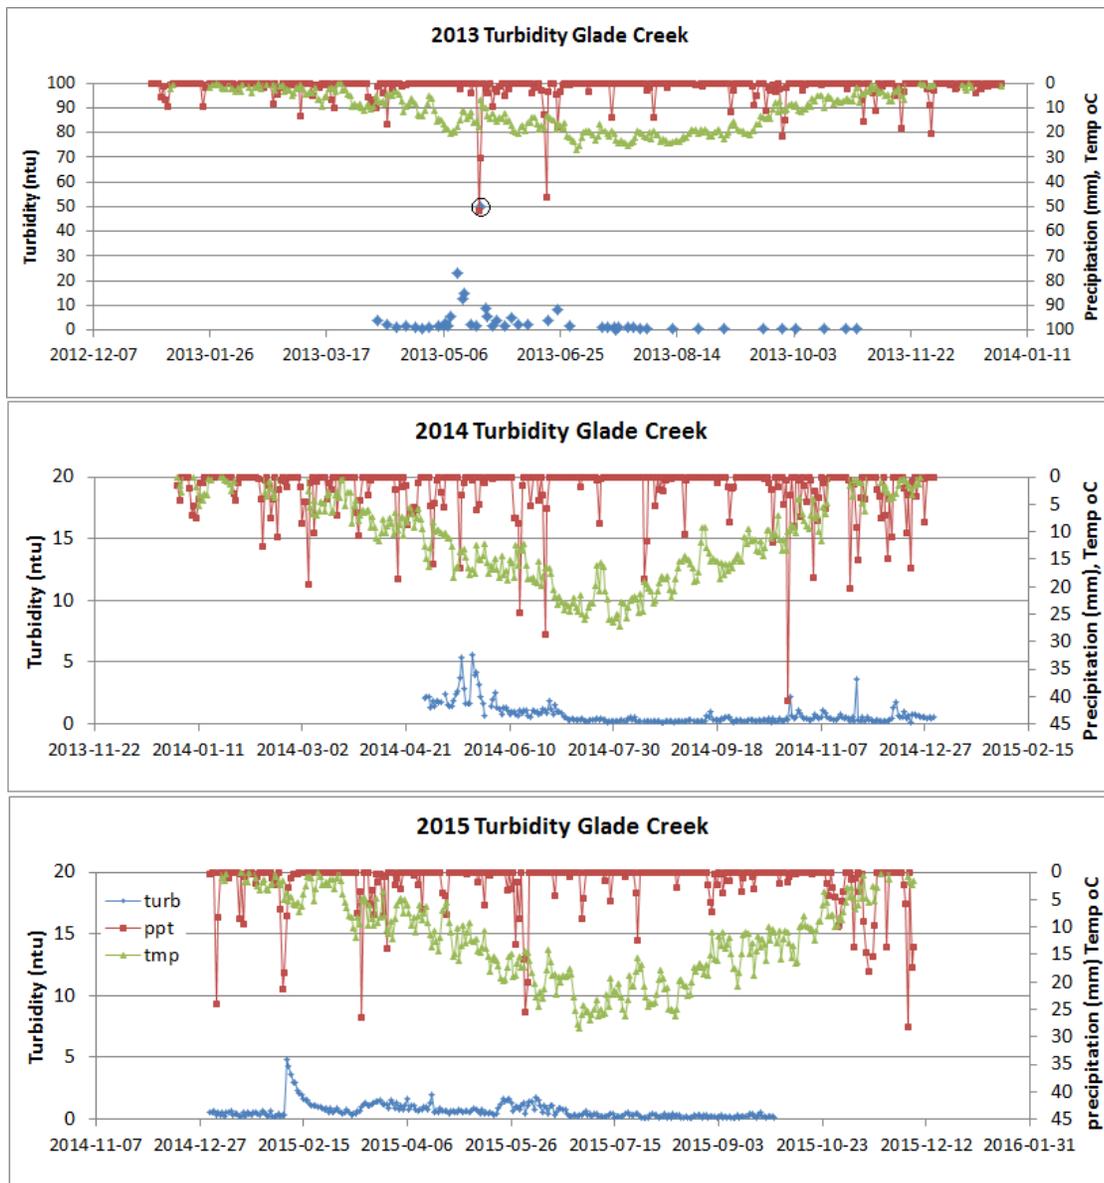
Figure 3. Turbidity data 2013 to 2015 from Glade Irrigation district website plotted with daily temperature and precipitation recorded at the Castlegar weather station. May 22 2013 data listed as 'off chart' is assigned 50 NTUs to represent an extreme reading for this day.

The lack of discharge gauging limits the ability to correlate turbidity with peak flow events. When turbidity data is plotted with the temperature and precipitation time series from Castlegar Airport for the same period of time (Figure 3) it shows that high turbidity events are limited in occurrence in Glade Creek and correspond to periods of heavy precipitation during winter months (February, 2015) or rainfall combined with rapid warming (June 2012 (not shown), May, 2013 and 2014) during spring

factors controlling turbidity in Glade Creek (Figure 3) indicates that precipitation events are associated with incidents of higher turbidity. Sediment sources in the lower elevation portion of the watershed including bank failures and the active debris slide in the canyon area are likely to contribute to increased suspended sediment during mid-winter or early spring rain-on-snow as these areas are less likely to be snow covered.

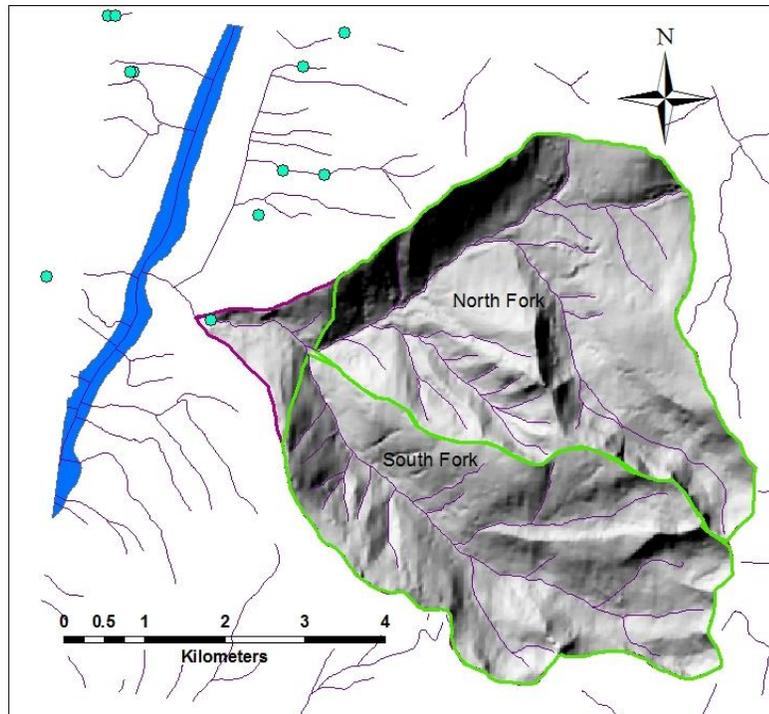
Figure 4. Relief map of Glade Watershed showing the north and south fork tributaries and the location of the Glade Irrigation District intake (blue dot).

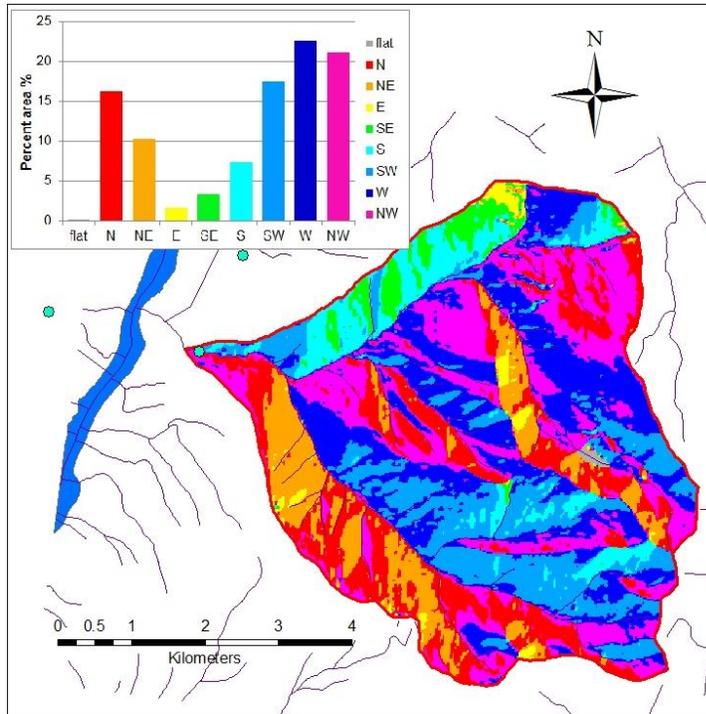
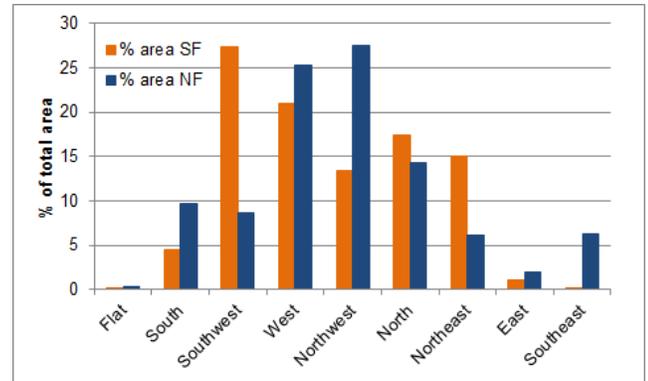
A GIS analysis of slope distribution in Glade Creek indicates that, over the entire watershed, slopes have predominantly west, southwest to northwest aspects. Western aspect slopes (W, NW, SW) account for over 60% of the aspect distribution in the watershed (Figure 5). When the two tributaries are considered separately the south fork tributary includes relatively more southwest and northeast aspect slopes while the north fork displays a greater amount of west and northwest aspect slopes.

Figure 5. Aspect distribution of Glade Creek and the two forks.

The predominance of northwest and north aspect slopes in the north fork tributary (Figure 5) south of the stream channel that account for 41% of the basin area results in much more synchronized snowmelt runoff to the stream network compared to the south fork. In addition, it is likely that the burned and sparsely vegetated south aspect slopes on the north side of the north fork channel melt off much earlier than the north-aspect slopes so that the main peak event in the north fork is driven almost entirely by late-season longwave driven snowmelt from the naturally shaded northwest to north aspect slopes. This mechanism of snowmelt (indirect longwave versus direct shortwave radiation) makes the north fork tributary less sensitive to harvesting related openings in the forest, but only for years where the

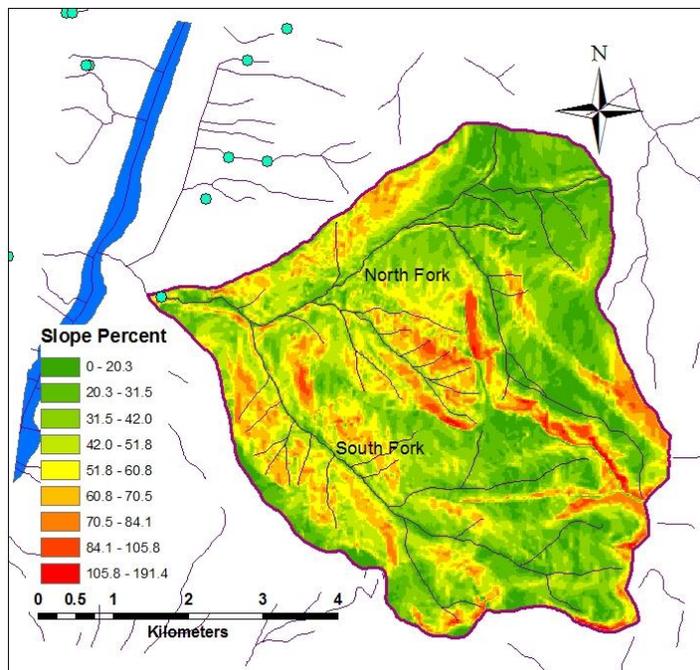
An analysis of slope gradient reveals that the majority of the watershed has moderate to gentle gradient slopes that are generally less than 50 percent (Figure 6). This figure shows that the headwaters of the north and south forks tributaries consist of low gradient bowls. A region of flat-over steep terrain is present along the western and southwestern boundary of the watershed and along the ridge between the north fork and south fork tributaries. Slopes greater than about 60% are generally limited to the upper elevation ridges and locally on the north side of the north fork and southwest side of the south fork tributaries.

Figure 6. Slope distribution of Glade Creek. Slope gradients range from 0 to over 100 % but the majority of slopes are less than about 60%. Headwaters are comprised of low gradient basins.

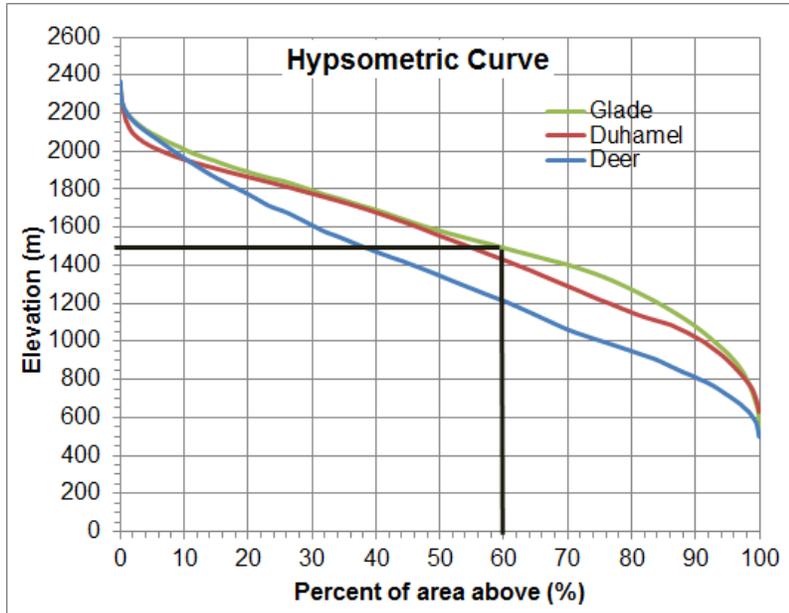
Figure 7. Elevation distribution (hypsometric curve) for Glade Creek. The curves for Duhamel and Deer Creeks are provided for comparison.

The elevation distribution of Glade Creek is investigated by plotting the hypsometric curve which shows the amount (in percent) of watershed area above a given elevation. A comparison with the hypsometric curves from some nearby watersheds shows that Glade Creek is a relatively high elevation watershed (Figure 7). The upper 50% of the watershed displays a similar elevation

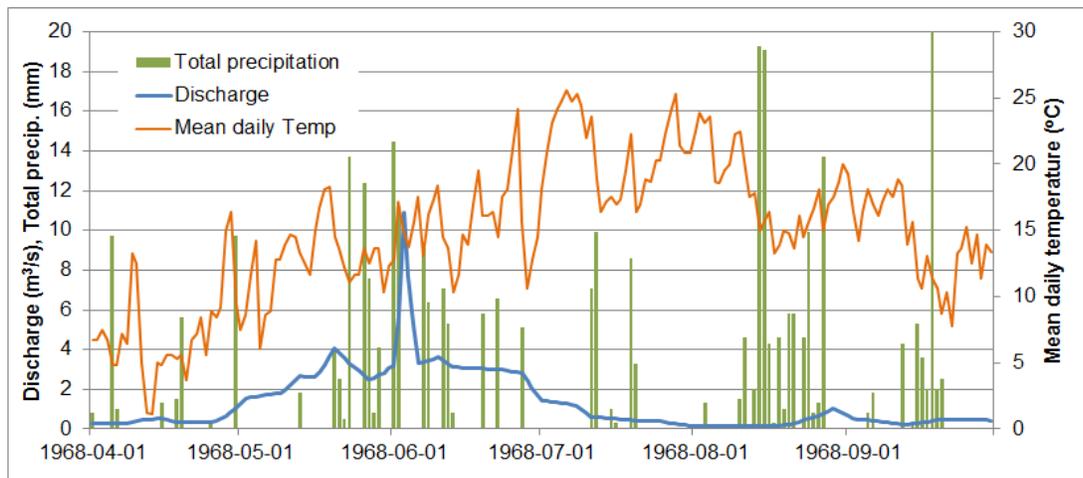
Figure 8. Discharge for Glade and daily precipitation and daily average temperature recorded at the Castlegar Airport for April 1st to September 30th 1968.

Although one year’s worth of data provides a limited amount of information it appears that flows began to increase in early May in response to a rise in daily temperature and continued to rise relatively gradually over a couple of weeks of warm and dry conditions. The peak discharge event of just under

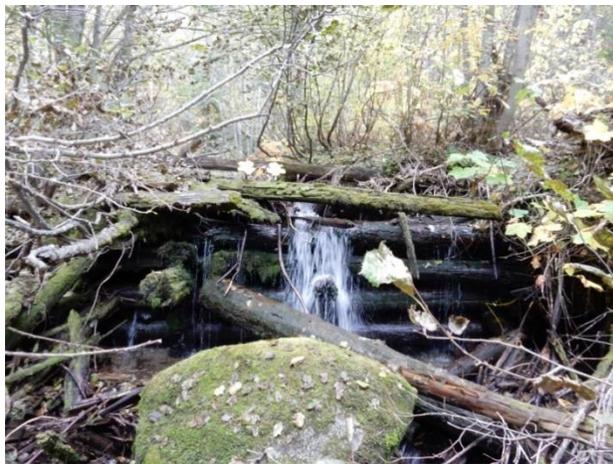
Photo 1. Looking upstream at a remnant of a log crib structure that spanned the north fork valley bottom. This structure appears to have been used as a retention dam to supply water to the flume system.

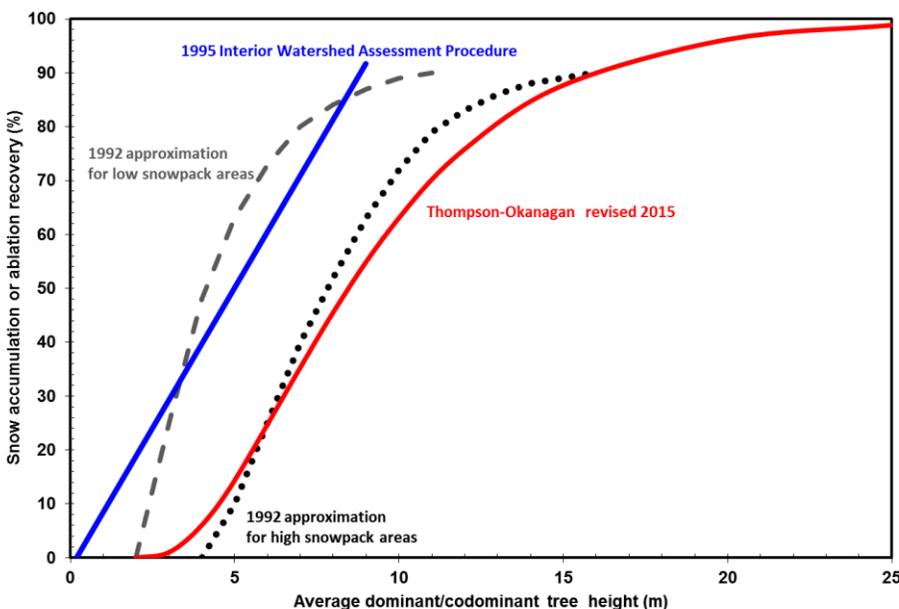
Figure 10. Recently developed hydrological recovery curve based on Rita Winkler's stand level studies in the Thompson and Okanagan Region.

Winkler and Boon (2015) determined that the amount of hydrological recovery depends on the stand height as well as the canopy density. The red curve shown in Figure 10 which is based on Winkler's research is

applicable to stands that have a stem density consistent with the pre-harvest condition. The recovery curve is not applicable to stands where the regenerating stand has a substantially lower stocking density than the undisturbed forest. In addition the recovery curve is developed for lodgepole pine and spruce – pine forest types typical of the Thompson-Okanagan.

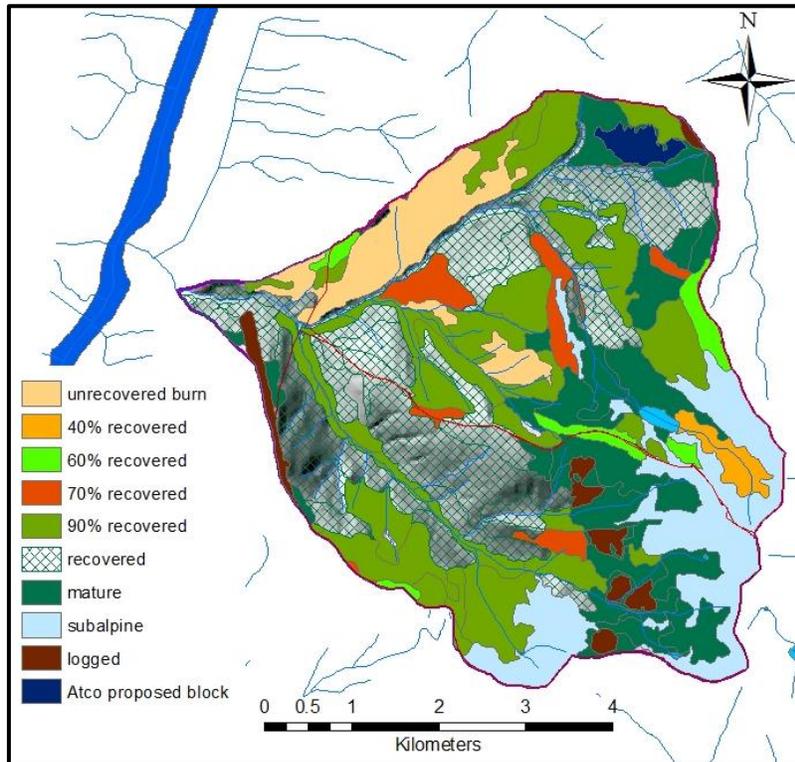
Figure 11. Existing cutblocks (brown) and partially recovered (green and orange) or unrecovered (buff) burned areas in Glade Creek. Proposed block of Atco is dark blue. Subalpine/alpine area is light blue.

Atco is proposing one block of 29.7 hectares along the northern boundary of the map area (blue block Figure 11). Atco's proposed logging will increase the existing ECA to 449 hectares or 15.1% of the total watershed area and will increase the ECA in the north fork to 325.5 ha or 21% of the 1561 ha subbasin.

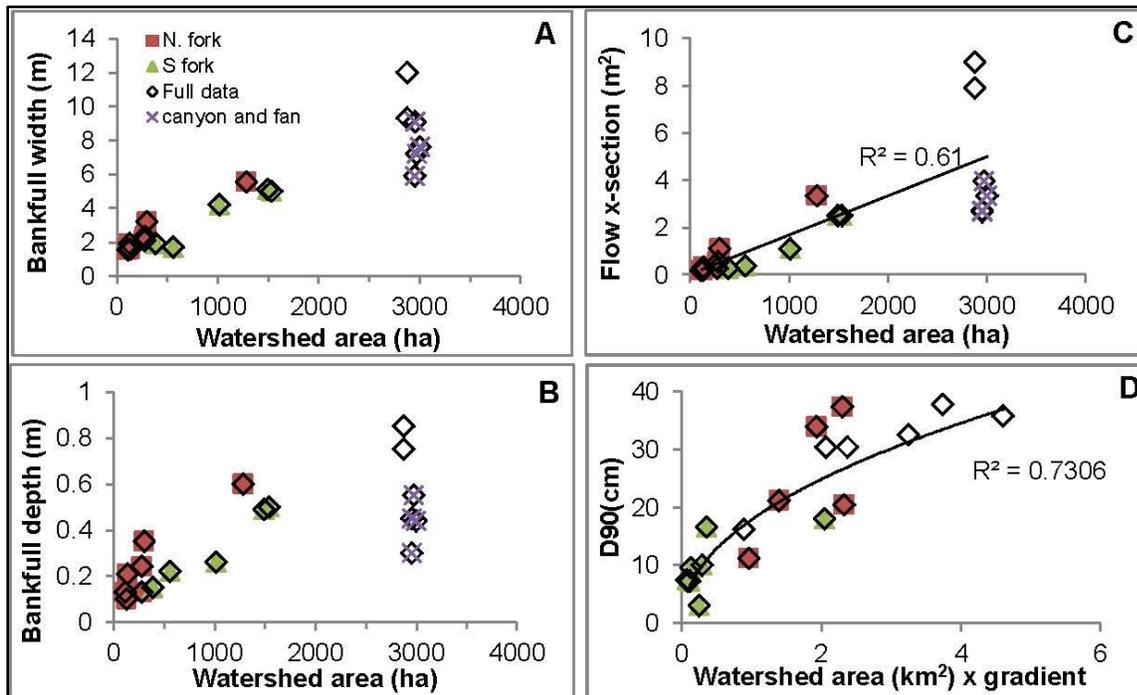
Figure 12. Hydraulic Geometry and maximum mobile grainsize relationships for Glade Creek.

The dynamics of sediment transport in Glade Creek is investigated using the trends between the largest frequently mobile grain (i.e. the largest bed material that is likely mobile during the bankfull flood), and stream power, which is the product of watershed area and channel gradient. The largest mobile grain is referred to as the D90 (the diameter of the grain is in the 90th percentile of obviously mobile grains at the sampling site). In Glade Creek there is an obvious increase in the size of the maximum mobile sediment with increasing stream power but there is a substantial amount of scatter to the data (Figure 12d). Additionally it appears that the maximum mobile grain for a given stream power is larger in the north fork tributary than the south fork tributary.

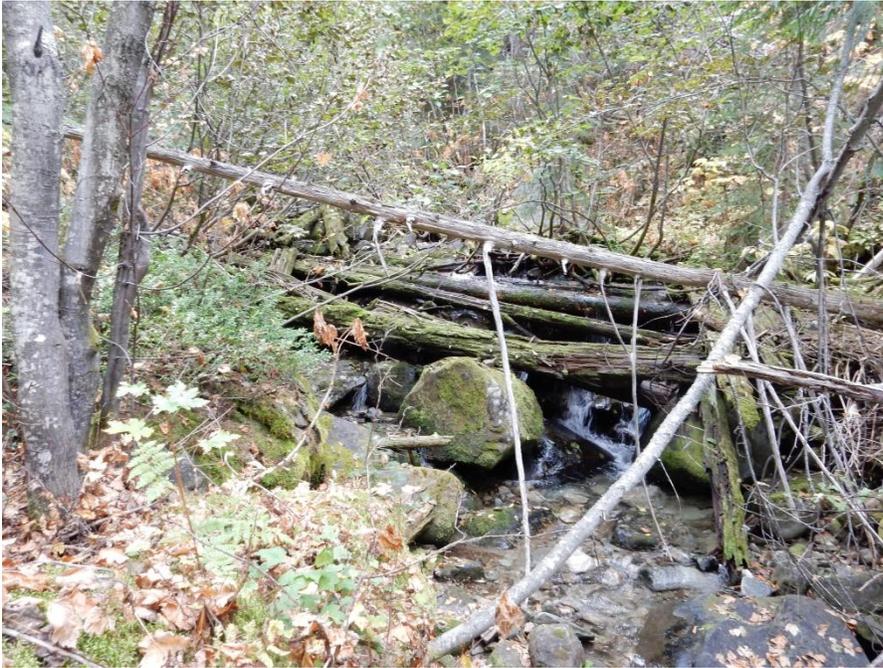
Photo 2. looking upstream in channel from Siwash lake. The deciduous riparian vegetation and the abundance of cut logs in the channel are the legacy of early 1900's logging.

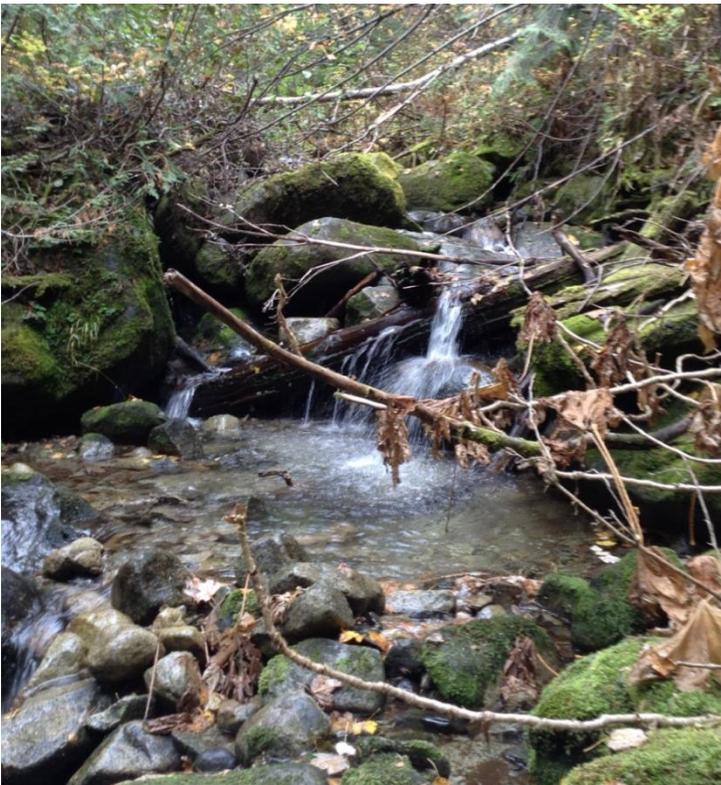
Photo 3. looking upstream on North Fork headwater below Siwash lake. Channel shows indications of very large debris flood that occurred roughly 50 years ago as well as extensive disturbance from logging.

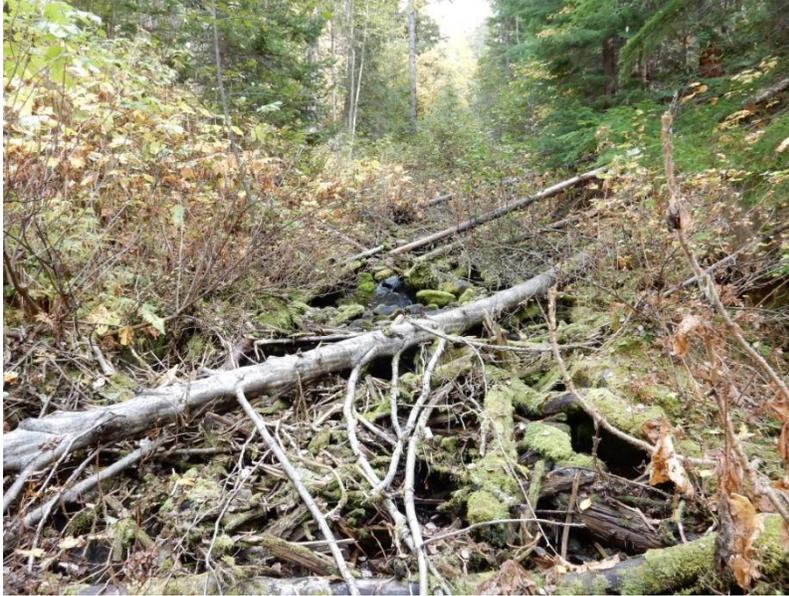
Photo 4. Northern branch of north fork tributary is smaller than the tributary from Siwash Lake. There is an extensive amount of disturbance in this tributary from past logging. The channel appears to have been skidded through during the 1920's logging.

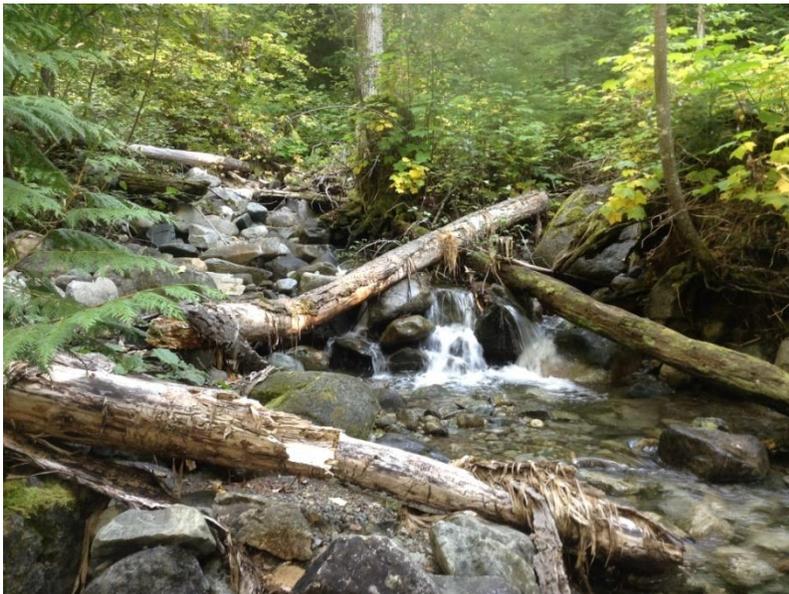
Photo 5. Looking upstream 700 meters upstream from the north and south fork tributary confluence. North fork channel shows recent disturbance from large flood as well as very extensive disturbance from 50 year old debris flood and the 1920's logging.

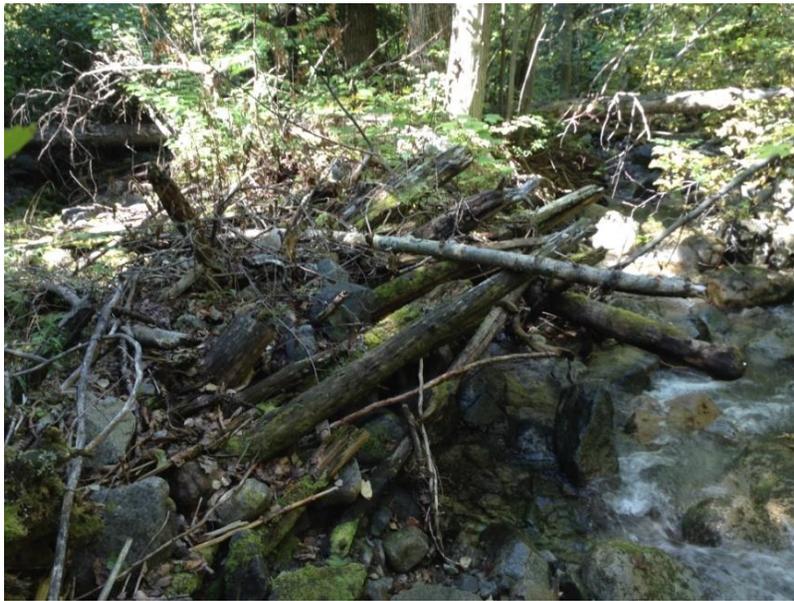
Photo 6. Large old woody debris jam from 1948 debris flood.

The large debris flood that occurred in 1948 caused the majority of the north fork channel to become mobile including the large boulders, pieces of woody debris and cut lumber. Large levees and debris deposits from this major debris flood occur along the length of the north fork tributary. Observations made during the field investigation suggest that failure of valley-spanning retention dams used for

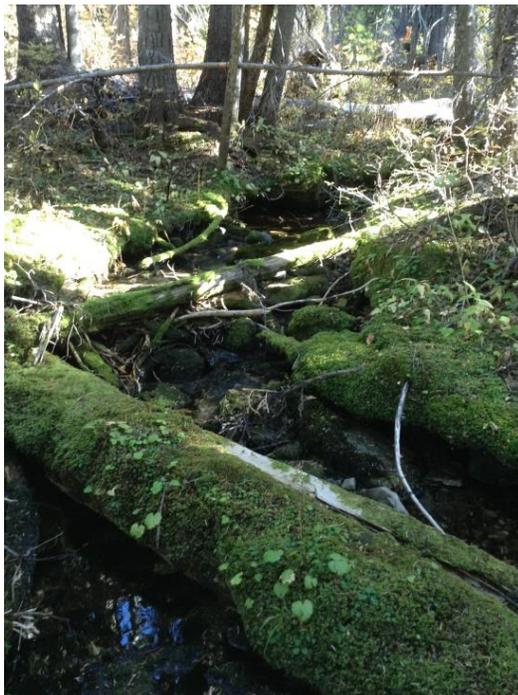
Photo 7. Looking upstream at survey site 20 in headwaters of south fork tributary.

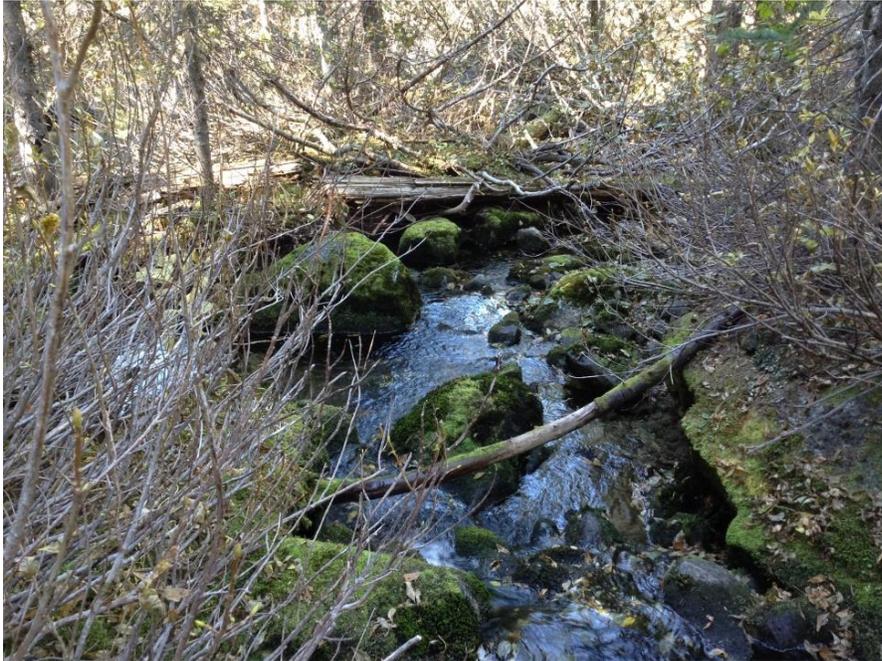
Photo 8. Looking downstream at site 12. Banks and larger colluvial blocks are mossy. Very old woody debris is functioning in the channel to retain sediment.

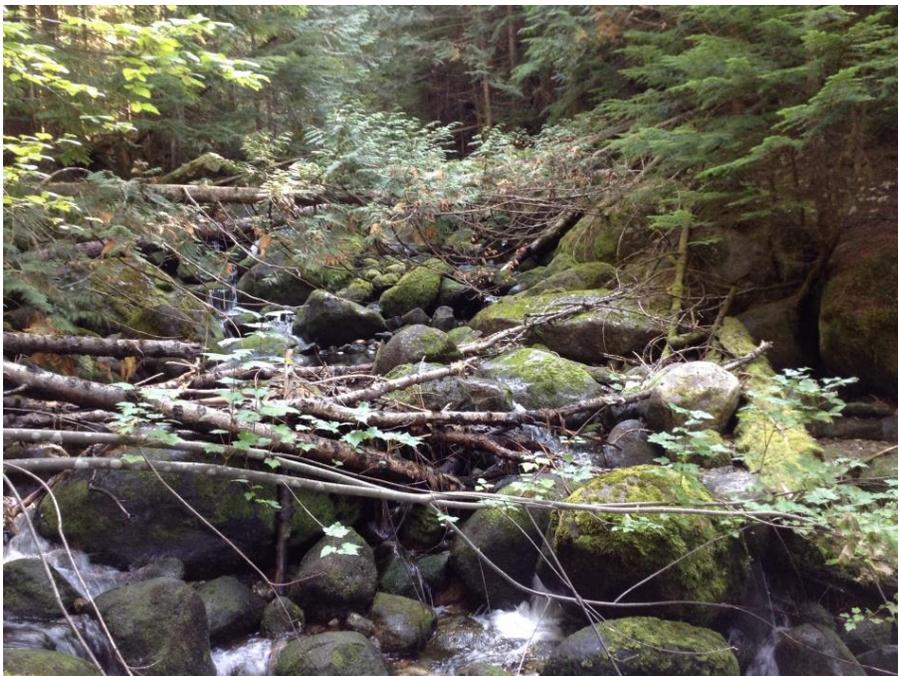
Photo 9. Looking upstream on the south fork at survey site 7 above north fork confluence. Channel is mossy, with a lag boulder cascade morphology.

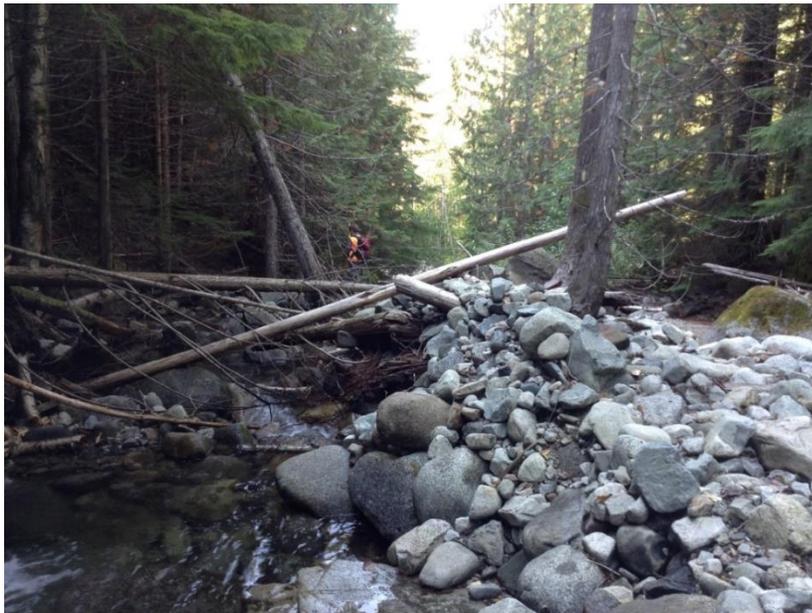
Photo 10. Looking downstream at recent debris flood deposit below confluence of north and south forks at survey site 9.

along the margins of the channel has been buried by over 2 meters of cobbles and woody debris. It is not clear why this portion of the Glade channel was so severely impacted but it may have resulted from the failure of an old debris jam in the lower reach of the north fork tributary. Boulders up to approximately 40 centimeter diameter were mobile during this recent large flood and mid channel levees are up to 2 meters high.

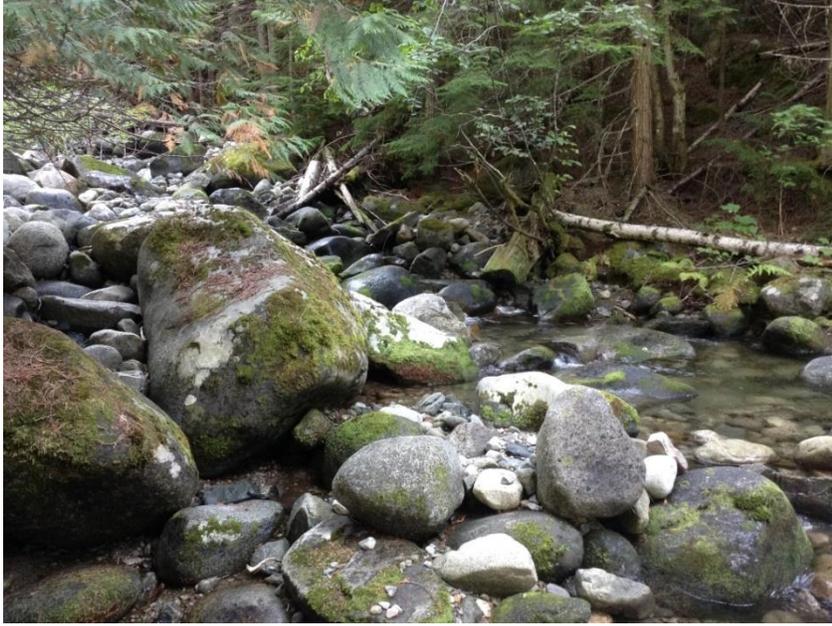
Photo 11. Survey site 10 shows much less recent flood disturbance than at site 9.

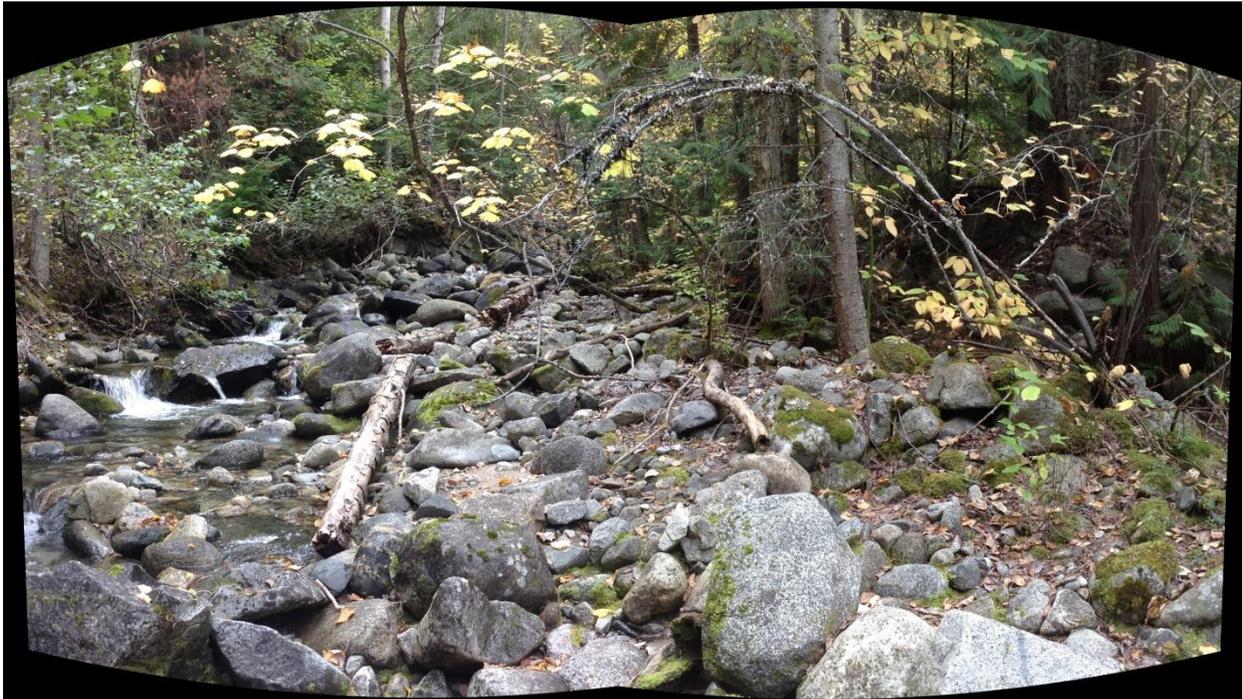
Photo 12. Panorama looking upstream at site 21. Mossy boulder levee on right is from 1948 flood.

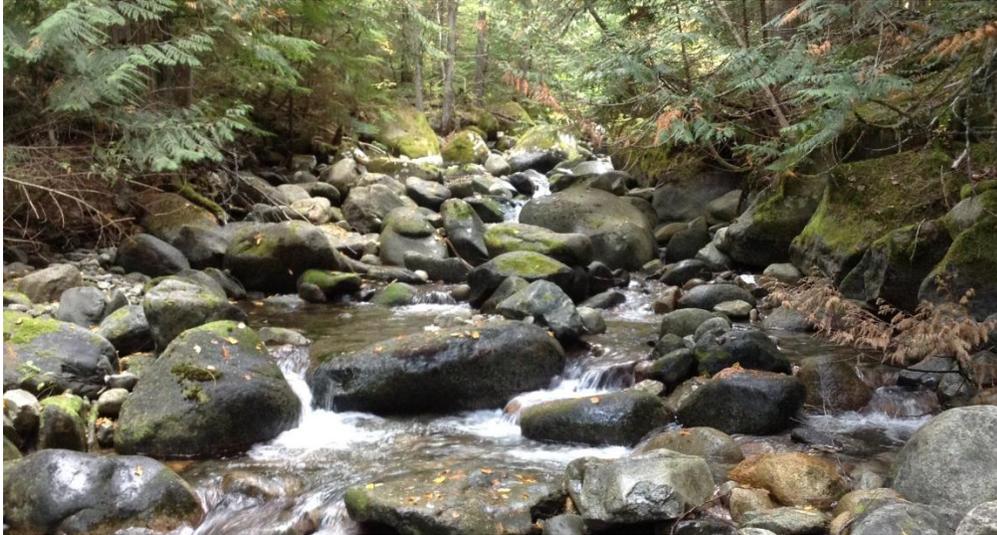
Photo 13. Looking upstream at site 23. Lag boulders in channel and along banks are from glacial moraine features that are present throughout the south fork and lower reaches of Glade Creek.

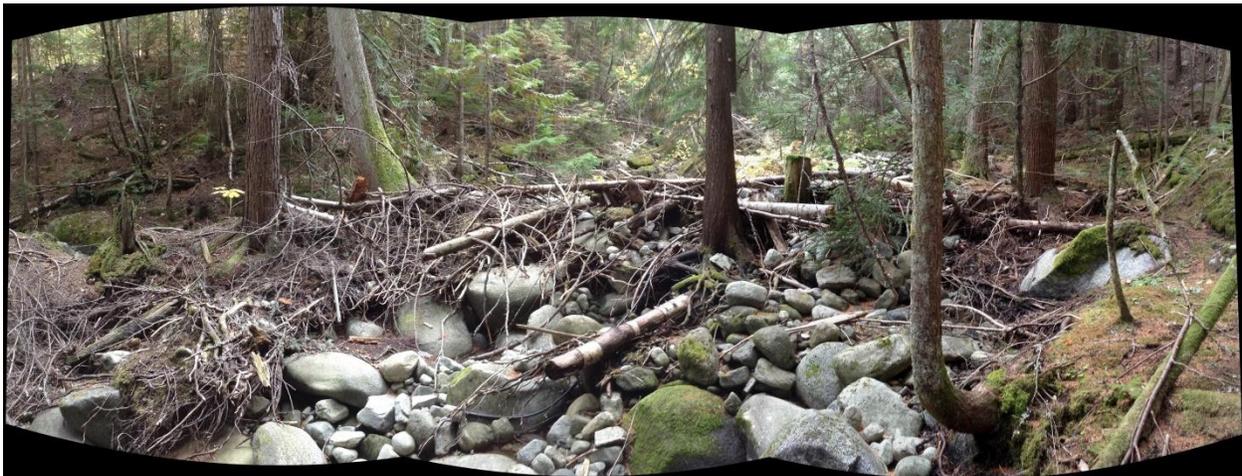
Photo 14. Looking upstream at recent debris flood deposits at site 24. This section of channel is about 100 meters downstream from site 23 (above) which displays little disturbance as a result of 2012 or 2013 flood.

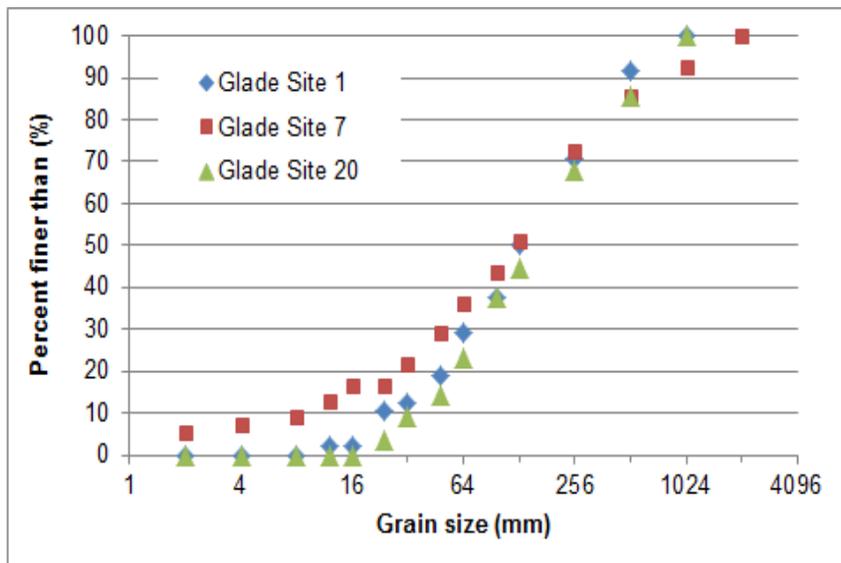
Figure 13. Grain size distribution for Survey site 1 (north fork), site 7 (lower south fork) and site 20 (upper south fork).

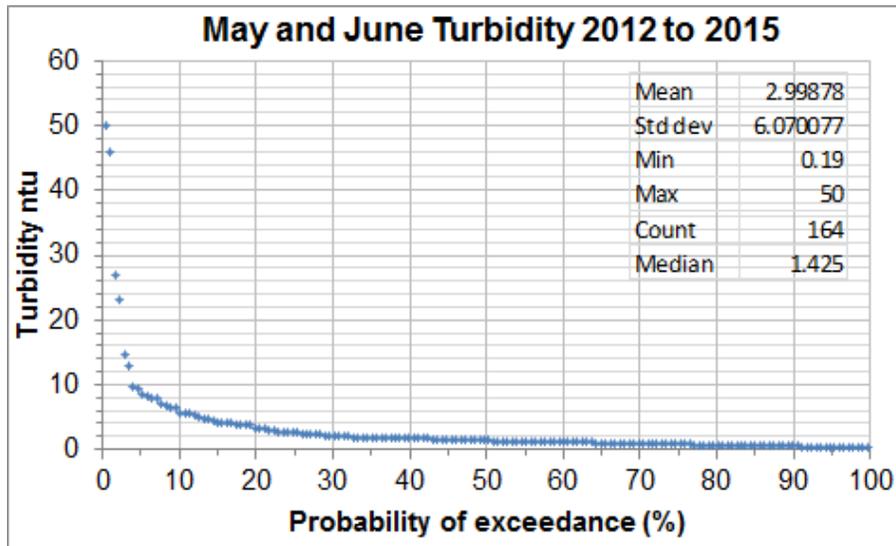
An analysis of the publicly available turbidity data for Glade Creek indicates that the May to June freshet period average turbidity for the 2012 to 2015 gauging period is 3 NTU's based on 164 samples (twice-daily samples collected in 2014 have been averaged, Figure 14).

Figure 14. Turbidity data collected during the freshet period by Glade Irrigation District between 2012 and 2015 (data accessed from Glade Irrigation District website)
