Glade Creek Hydrogeomorphic Assessment

Apex File HA-15-KL-02

Prepared by: Kim Green, PGeo., PhD.
Apex Geoscience Consultants Ltd
Nelson, BC

January 20, 2016

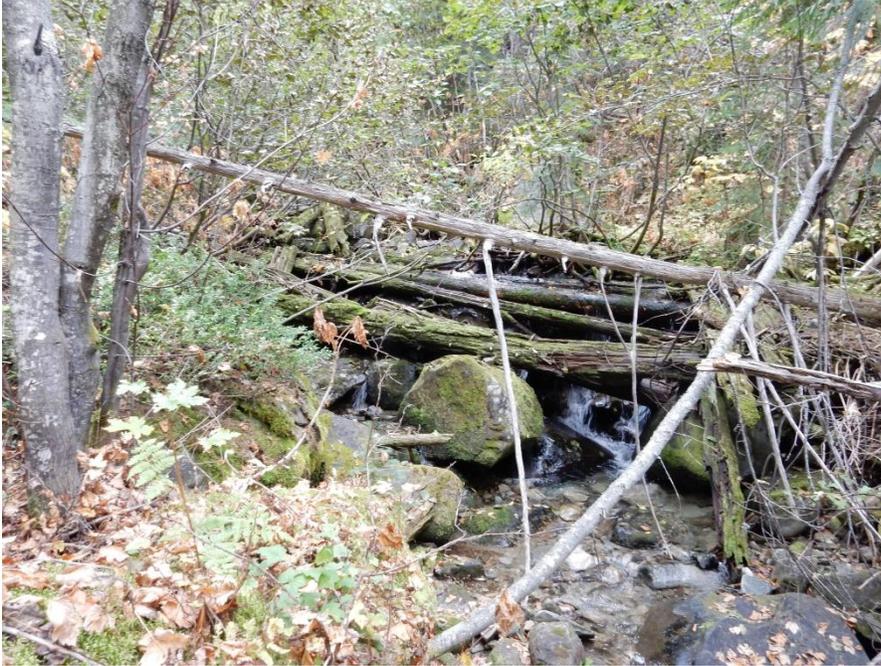
Photo 2. looking upstream in channel from Siwash lake. The deciduous riparian vegetation and the abundance of cut logs in the channel are the legacy of early 1900's logging.

The channel below Siwash Lake is the main headwater tributary of the north fork of Glade Creek. Only the lower two hundred meters of this headwater tributary were observed in the field.

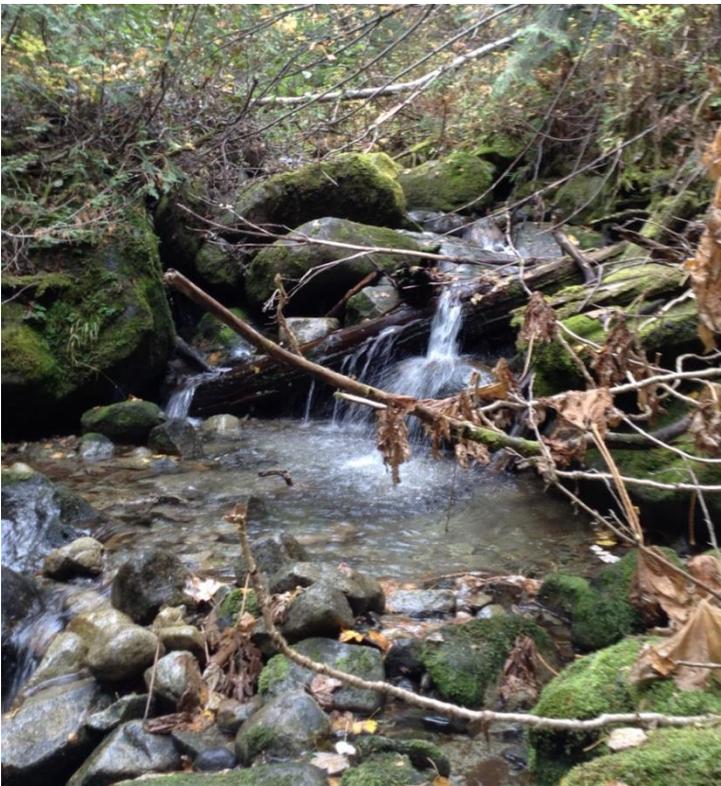
Photo 3. looking upstream on North Fork headwater below Siwash lake. Channel shows indications of very large debris flood that occurred roughly 50 years ago as well as extensive disturbance from logging.

The channel shows indicators of a large debris flood that is at least 50 years old as well as a smaller recent flood that has mobilized material up to large cobble size and formed cobble deposits behind woody debris.

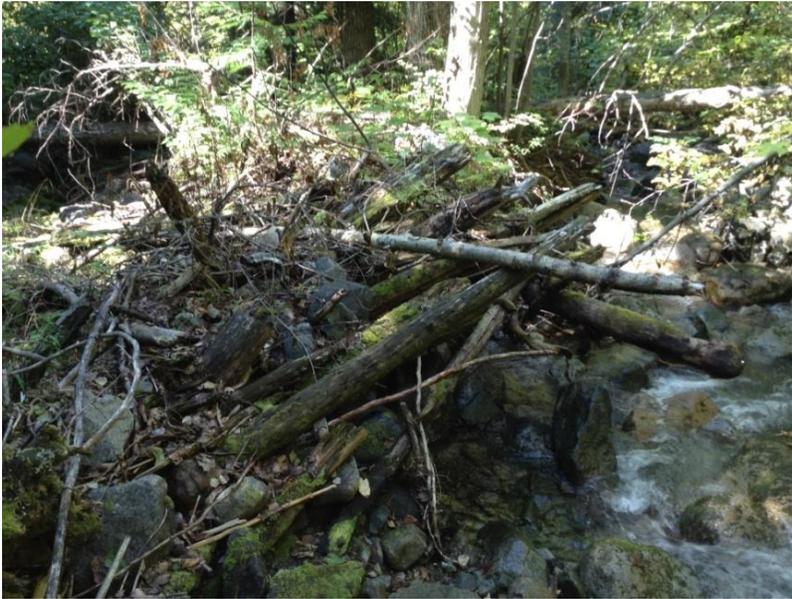
Photo 6. Large old woody debris jam from 1948 debris flood.

The large debris flood that occurred in 1948 caused the majority of the north fork channel to become mobile including the large boulders, pieces of woody debris and cut lumber. Large levees and debris deposits from this major debris flood occur along the length of the north fork tributary. Observations made during the field investigation suggest that failure of valley-spanning retention dams used for

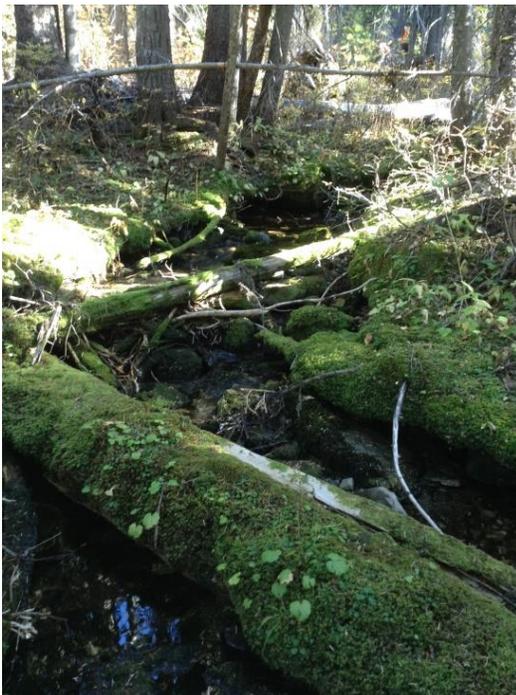
Photo 7. Looking upstream at survey site 20 in headwaters of south fork tributary.

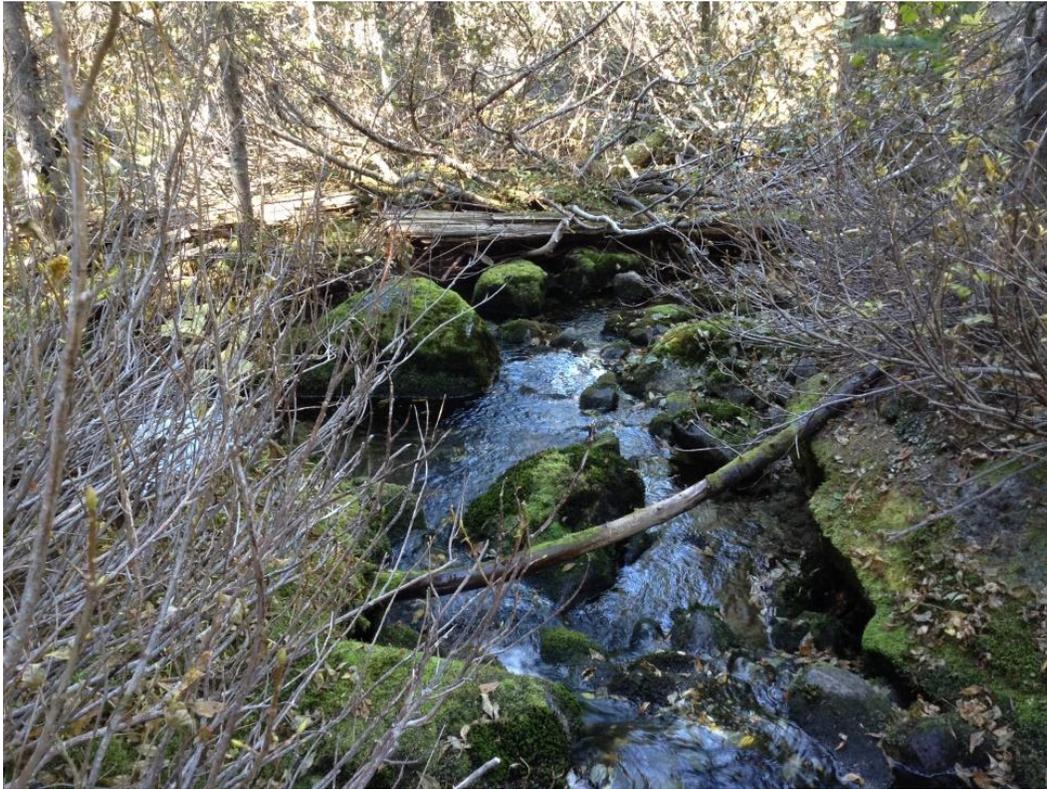
Photo 8. Looking downstream at site 12. Banks and larger colluvial blocks are mossy. Very old woody debris is functioning in the channel to retain sediment.

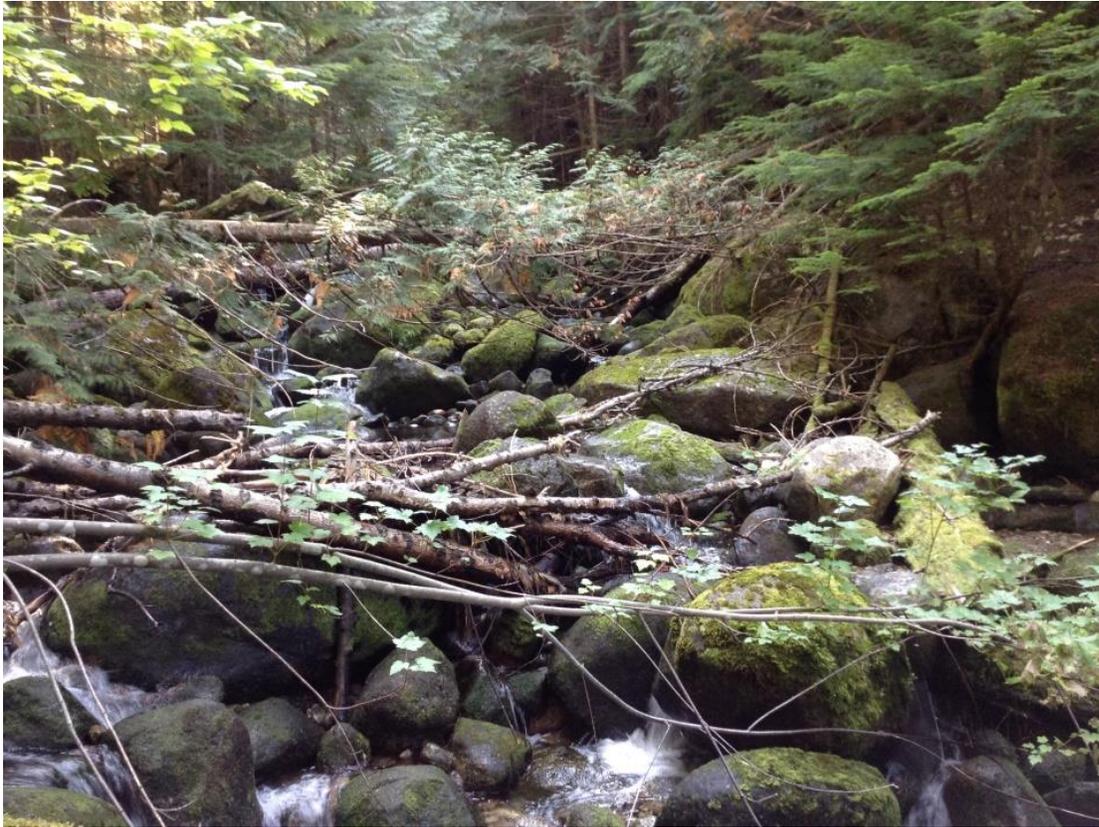
Photo 9. Looking upstream on the south fork at survey site 7 above north fork confluence. Channel is mossy, with a lag boulder cascade morphology.

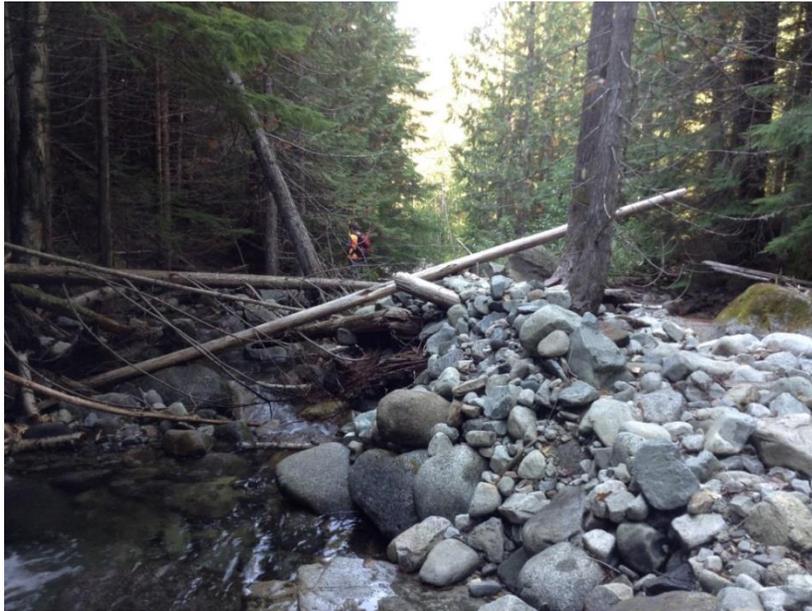
Photo 10. Looking downstream at recent debris flood deposit below confluence of north and south forks at survey site 9.

has been buried by over 2 meters of cobbles and woody debris. It is not clear why this portion of the Glade channel was so severely impacted but it may have resulted from the failure of an old debris jam in the lower reach of the north fork tributary. Boulders up to approximately 40 centimeter diameter were mobile during this recent large flood and mid channel levees are up to 2 meters high.

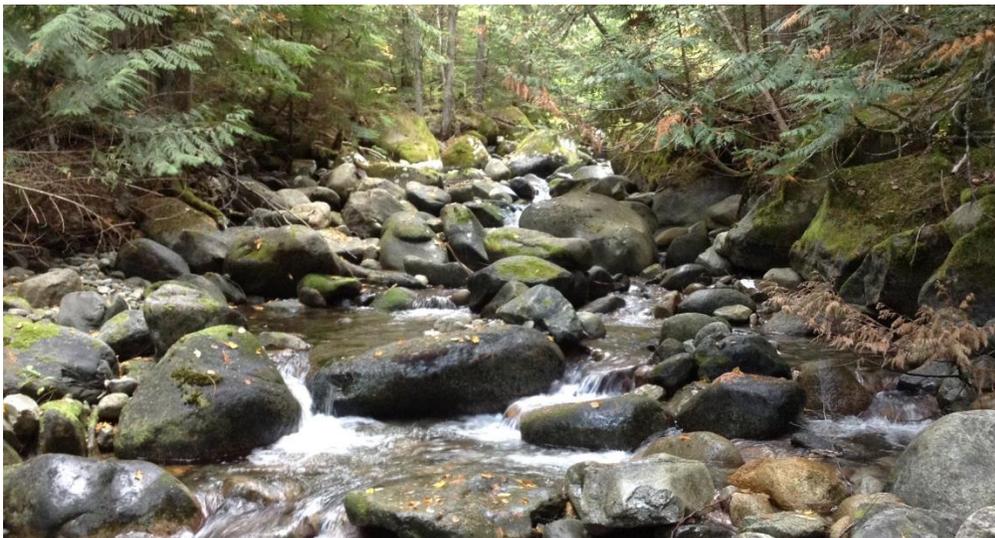
Photo 13. Looking upstream at site 23. Lag boulders in channel and along banks are from glacial moraine features that are present throughout the south fork and lower reaches of Glade Creek.

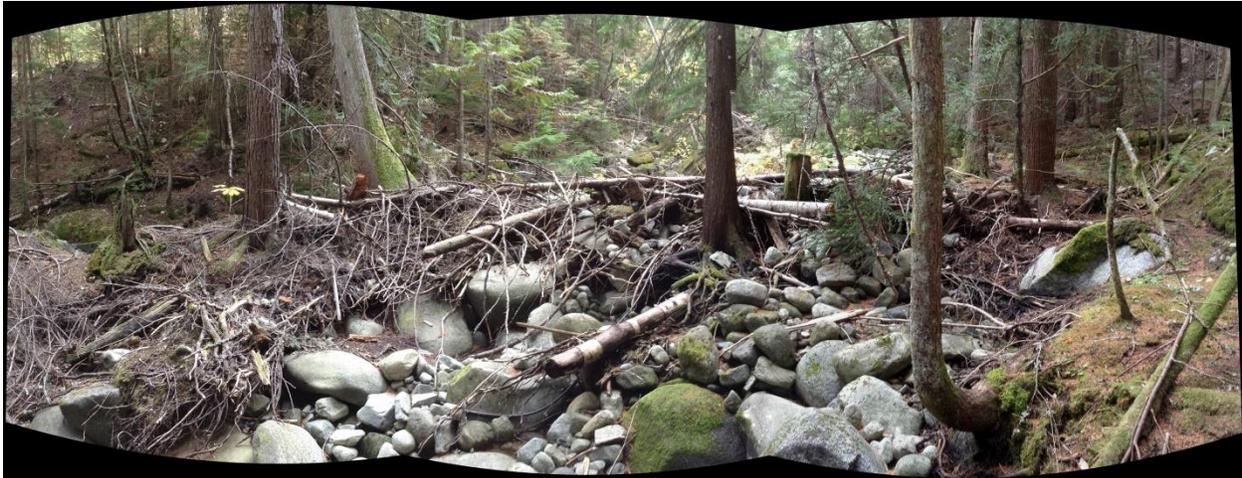
Photo 14. Looking upstream at recent debris flood deposits at site 24. This section of channel is about 100 meters downstream from site 23 (above) which displays little disturbance as a result of 2012 or 2013 flood.
